N-Series' coin battery Issue

15th November. 2016

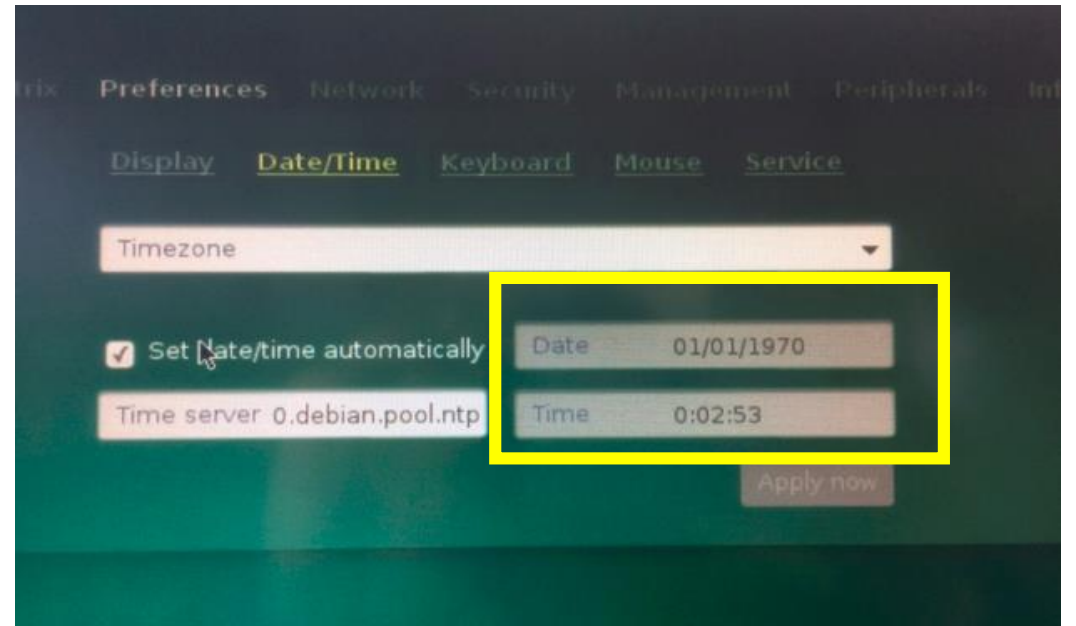
Symptoms

- After device booting, you can see "01 Jan 1970" on bottom side of monitor or can't change "time setting" in Date/Time of setup display
